APPENDIX A

MOORES RUN - REACH PHOTOGRAPHS

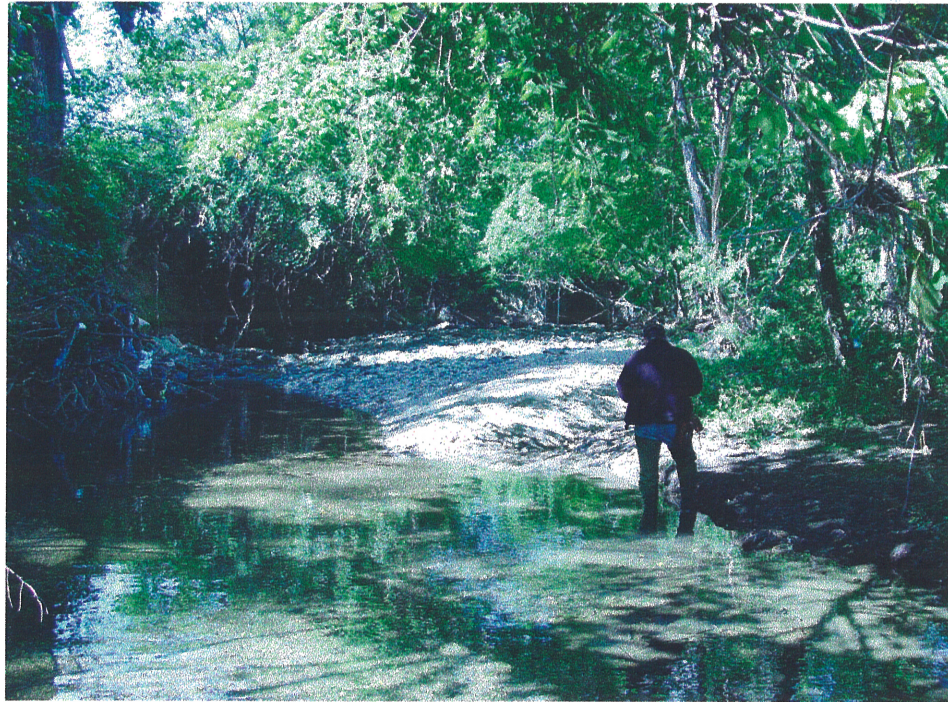
Photo 1. Reach 01 is a Rosgen C stream type with well-developed lateral bars (looking upstream).

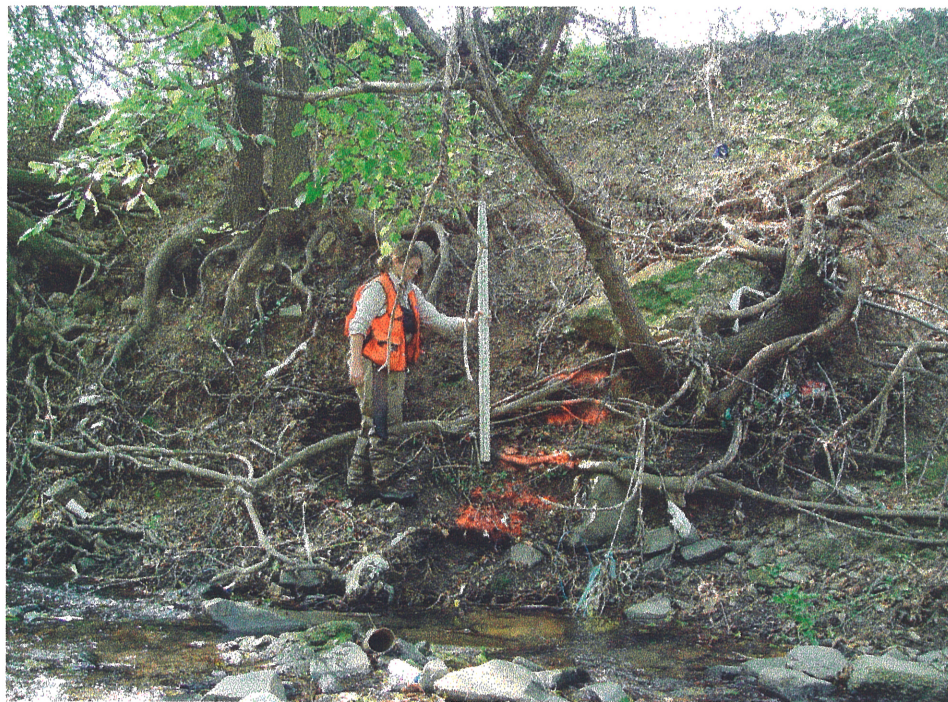
Photo 2. Reach 01 has banks with extreme bank erosion potential that contribute to a moderately unstable lateral stability rating.

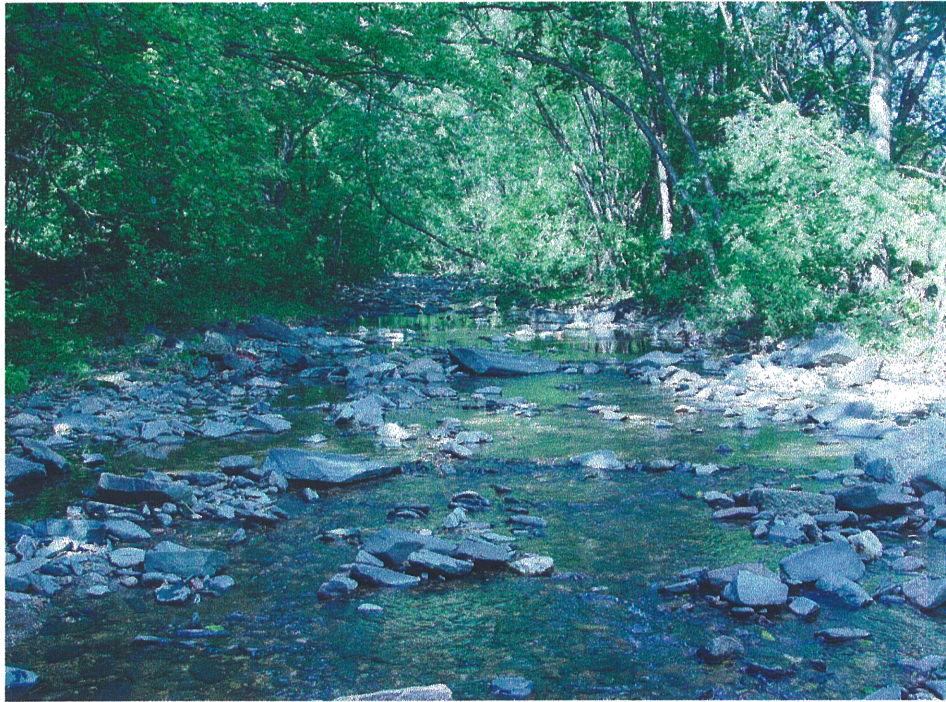
Photo 3. Reach 02 is a Rosgen C stream type with a moderate width/depth ratio, low entrenchment, and cobble and boulder dominated substrate.

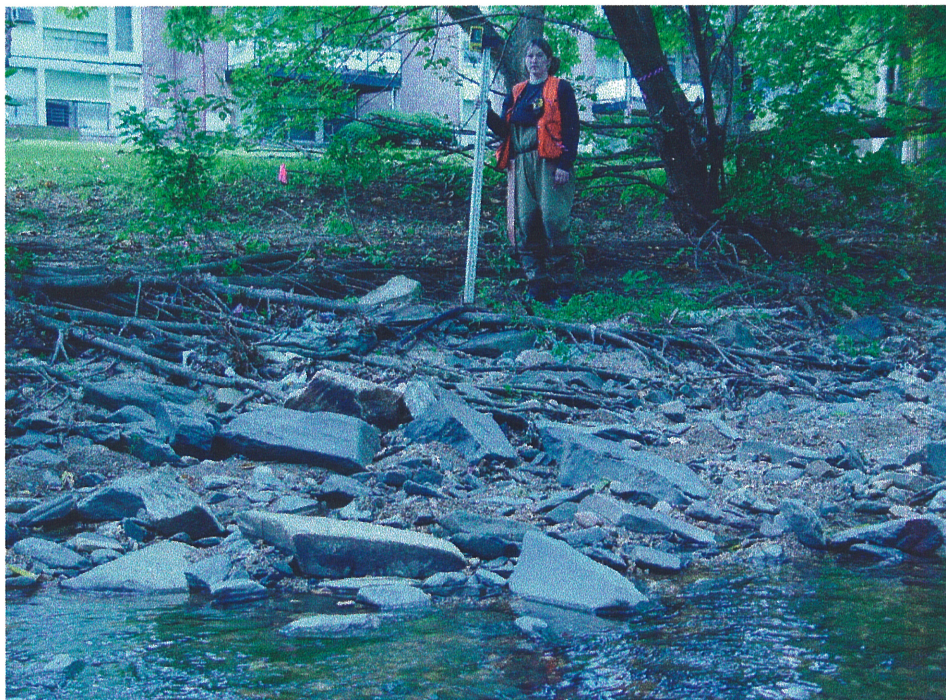
Photo 4. Reach 02 banks are moderately sloped and well protected by vegetation and cobbles which contribute to a stable lateral stability rating.

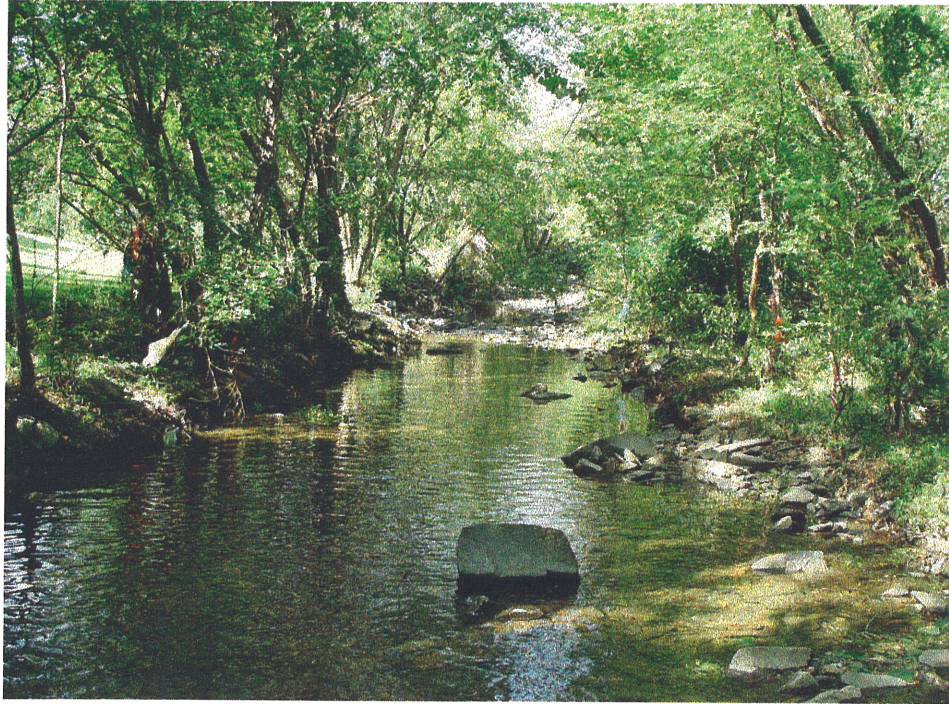
Photo 5. Reach 03 is a Rosgen D stream type with two braids. This photograph (looking upstream) shows the right channel which carries the majority of the flows.

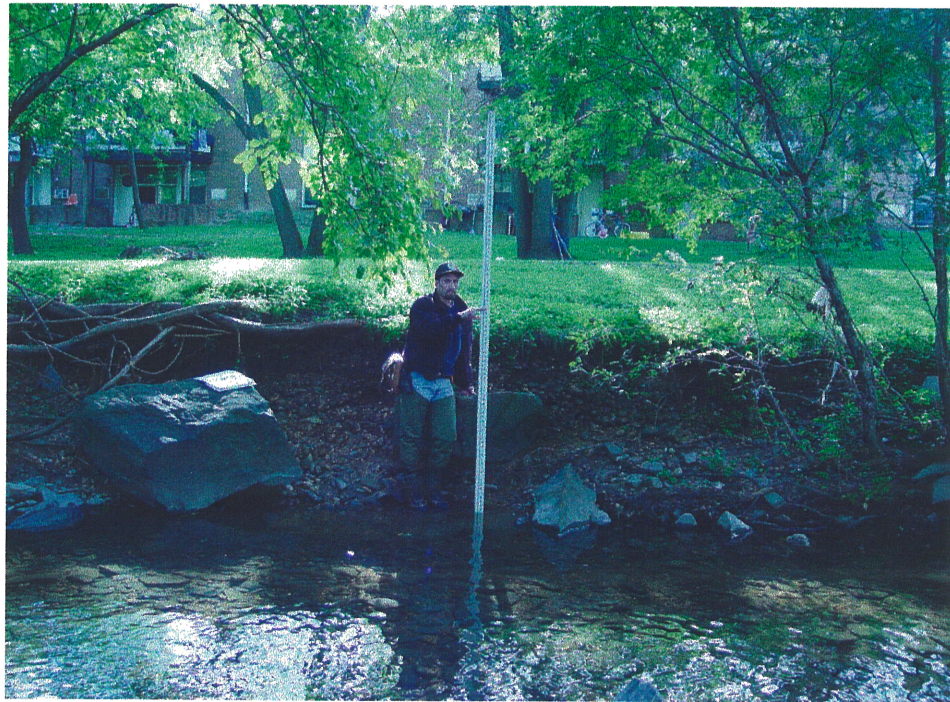
Photo 6. Although this bank has a high erosion potential, the majority of banks in Reach 03 have low erosion potential.

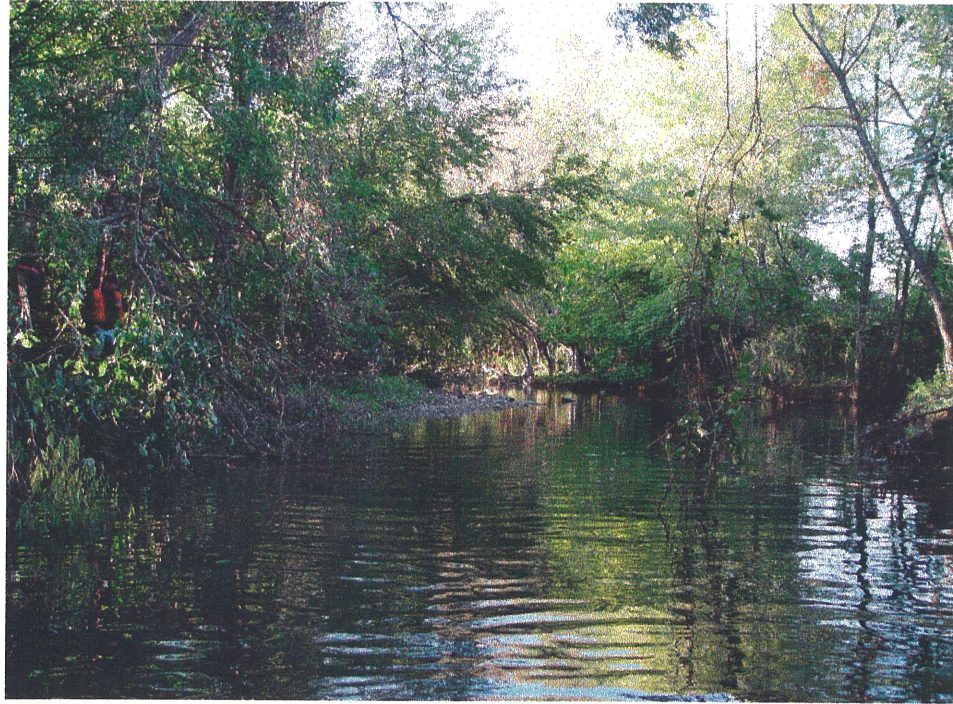
Photo 7. Reach 04 is a transitional reach consisting of one long pool and one long run.

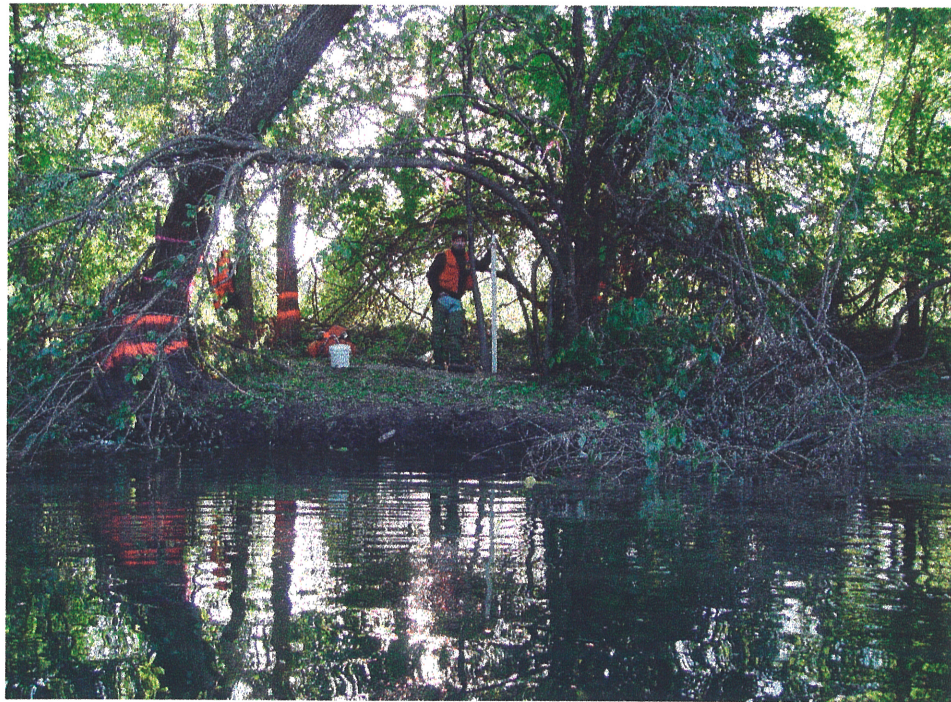
Photo 8. The right bank of Reach 04 is typical of the reach conditions with very low to moderate erosion potential.

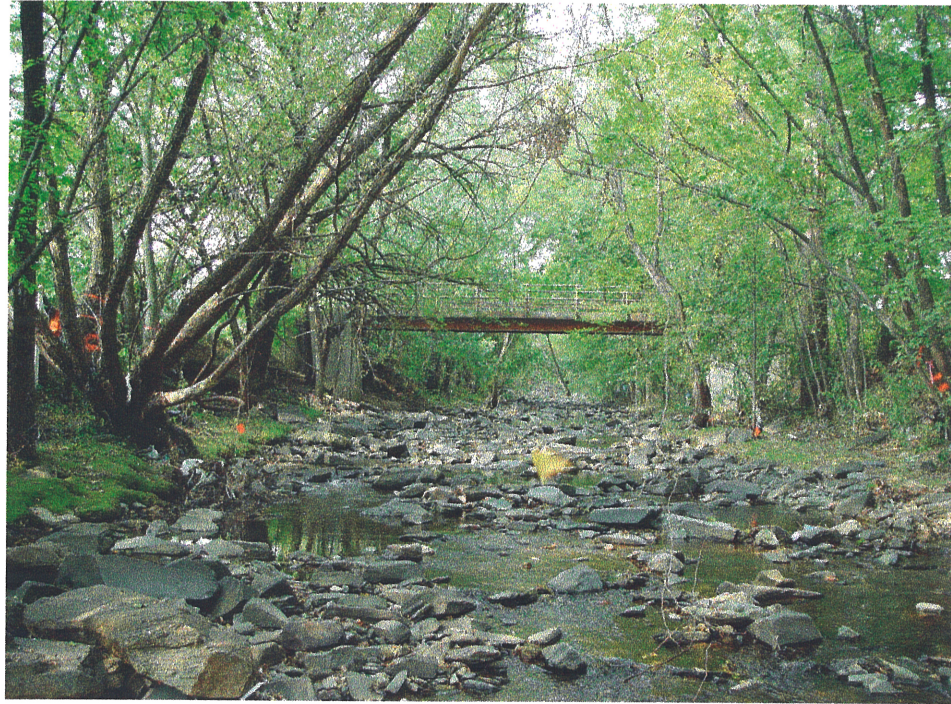
Photo 9. Reach 05 is a Rosgen F stream type that is highly entrenched with high, steep banks and a moderate width/depth ratio.

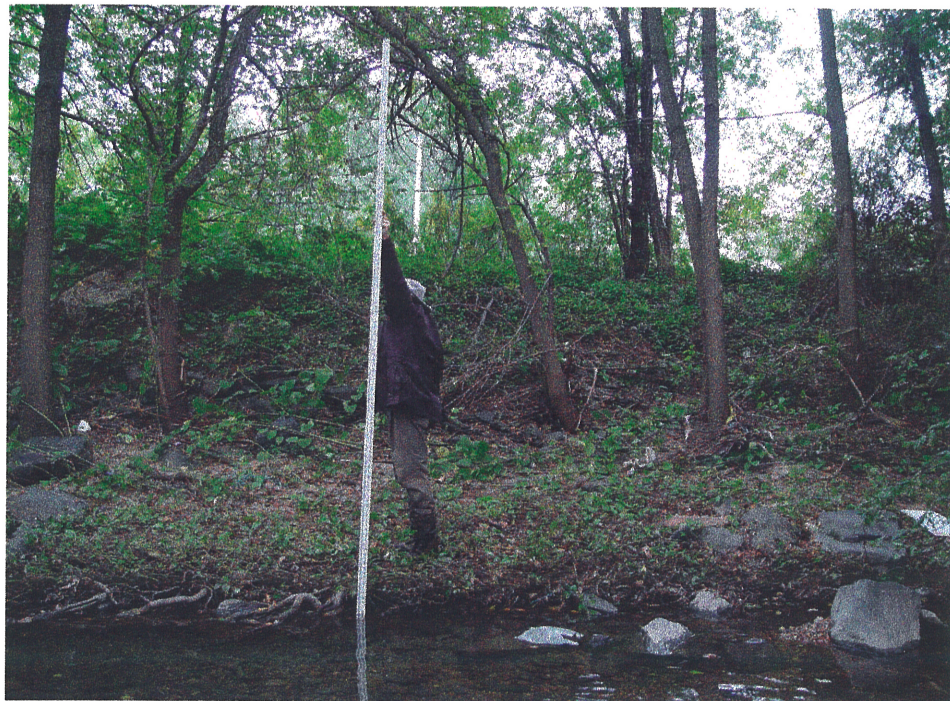
Photo 10. Even though Reach 05 is highly entrenched and contains large flood flows within the channel, the banks remain stable as a result of well established vegetation on the entire bank.

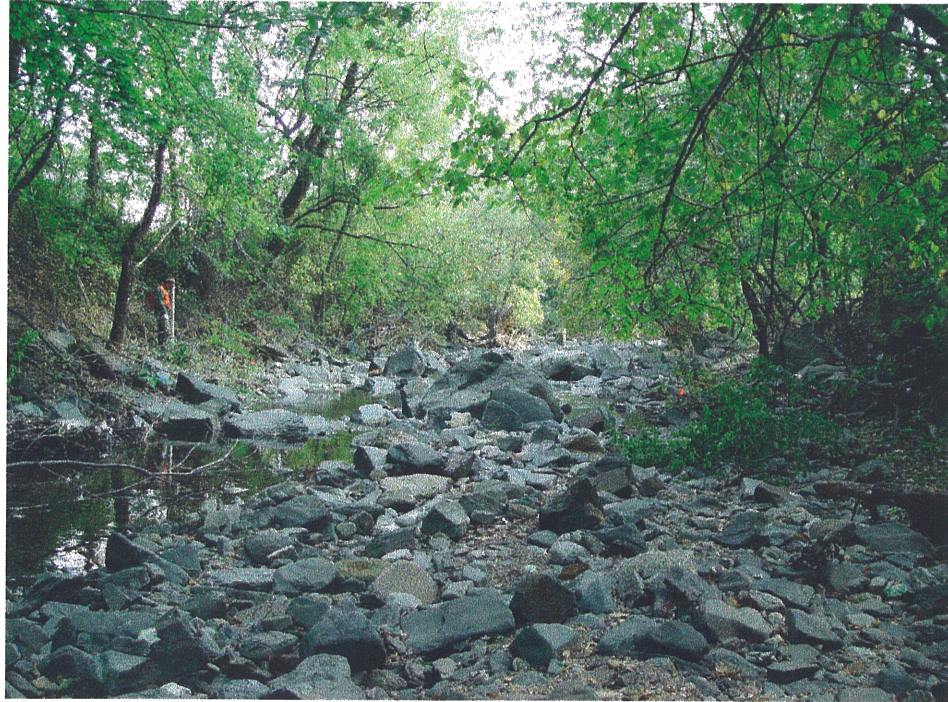
Photo 11. Like Reach 5, Reach 06 is a Rosgen F stream type, but with a steeper reach average slope (0.016 ft/ft) than Reach 5 (0.012 ft/ft) and cobble dominated substrate with bedrock controls.

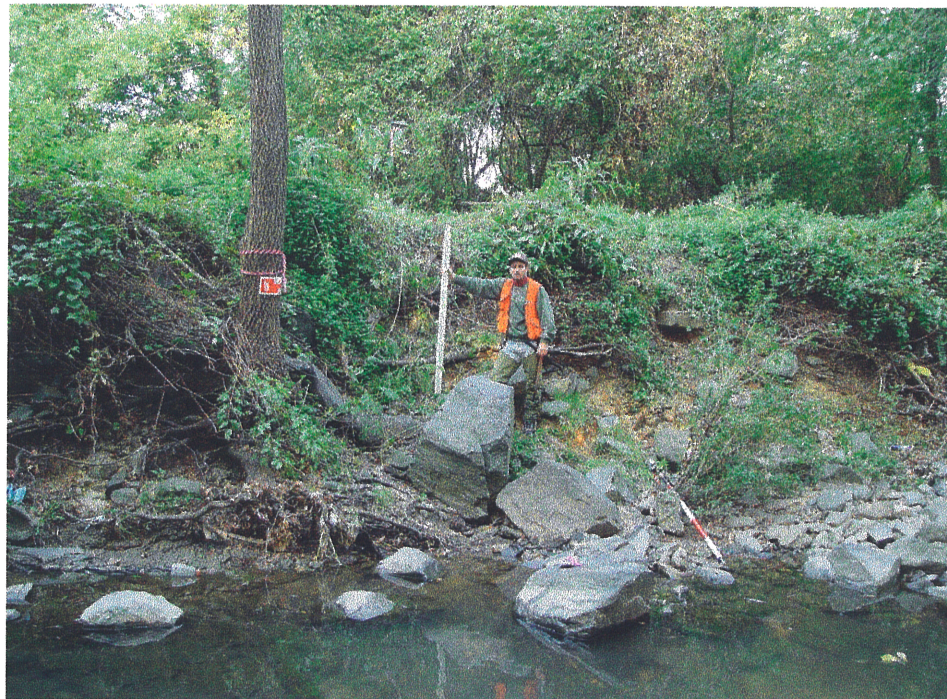
Photo 12. Forty-one percent of the banks in Reach 06 have a moderate erosion potential because the stream lacks an adequate floodplain and well established riparian vegetation.

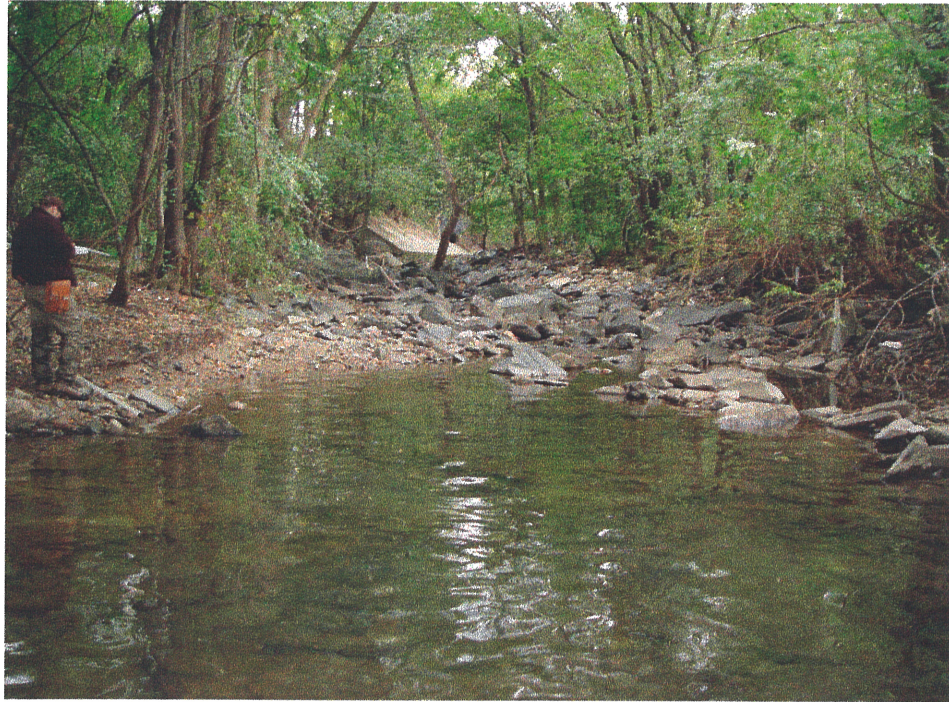
Photo 13. Reach 07 is a Rosgen B stream type. The reach is stable because the channel has a floodprone area that assists in reducing channel erosive flows.

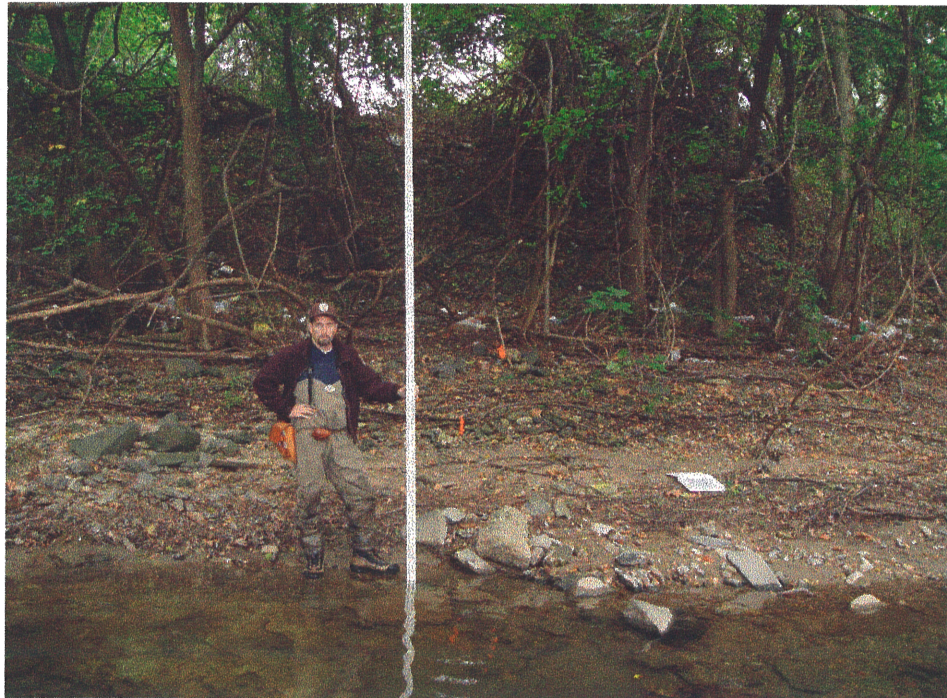
Photo 14. Reach 07 banks are well vegetated which contributes to its low lateral stability rating.

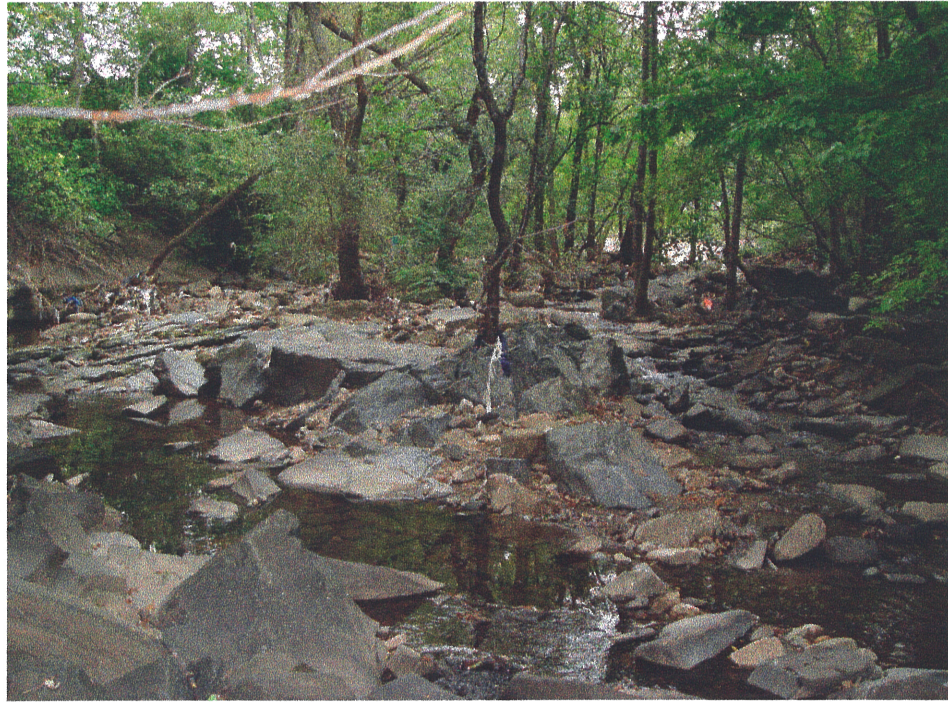
Photo 15. Reach 08 is a Rosgen D stream type (braided). It has three channels; two main channels and one connecting channel. This photograph, looking upstream, shows the left main channel.

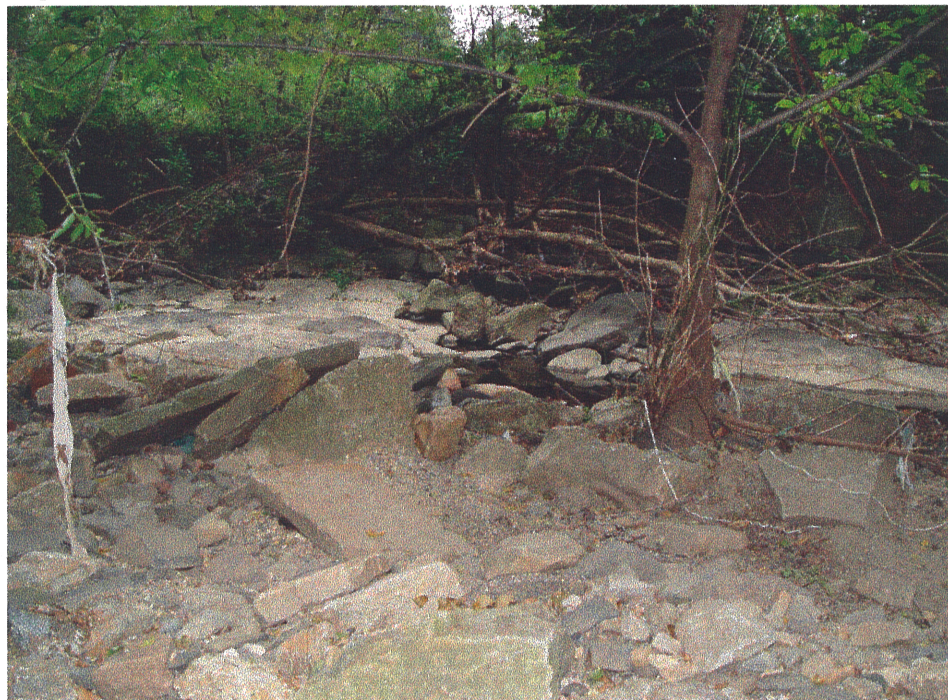
Photo 16. Boulders along the left bank of Reach 08 contribute to its low erosion potential. The right bank is a sloping concrete slab. Reach 8 also has bedrock grade controls throughout.

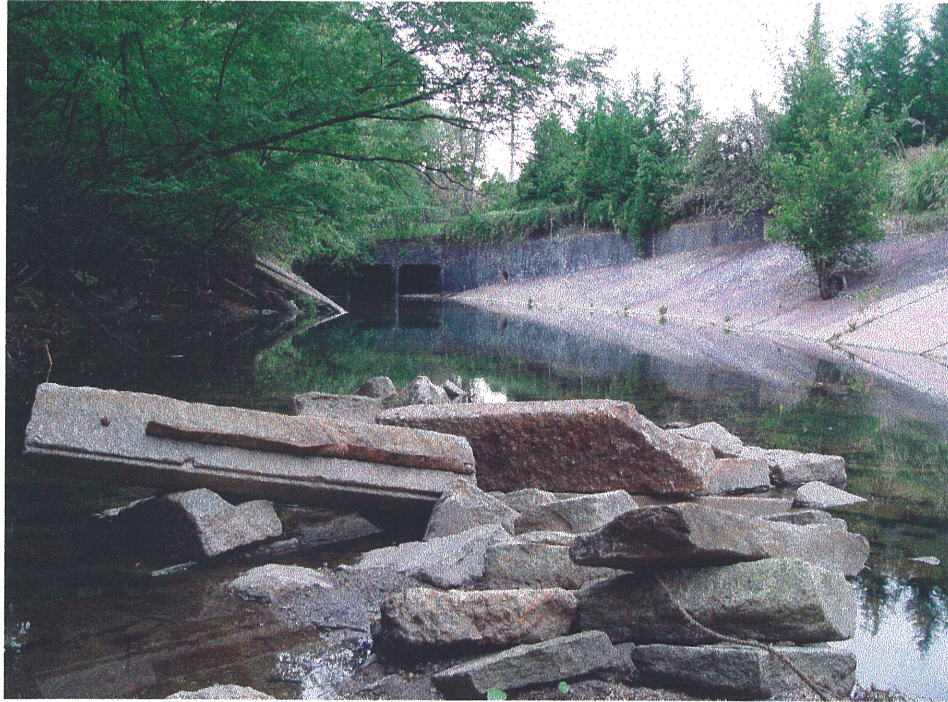
Photo 17. Reach 09 is a transition coming out of a triple-cell box. It consists of one large pool which has concrete rubble throughout.

Photo 18. The left bank of Reach 09 (shown in this photograph) has a very high erosion potential and the right bank (shown in photograph 17) is a sloped concrete slab.
